## PHASE 1 MILESTONE INSPECTION REPORT

**9<sup>th</sup> Fairway Condominium at Green Dolphin Park, Inc.**

1700,1800,1900 Golfview Drive Tarpon  
Springs, FL 34689

November 29th, 2023

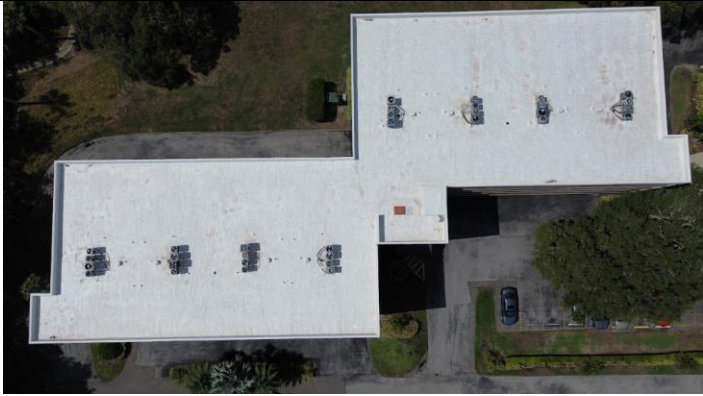
2. Roof Overview

Roofing is a modified bitumen system with a foam and silicone overlay.

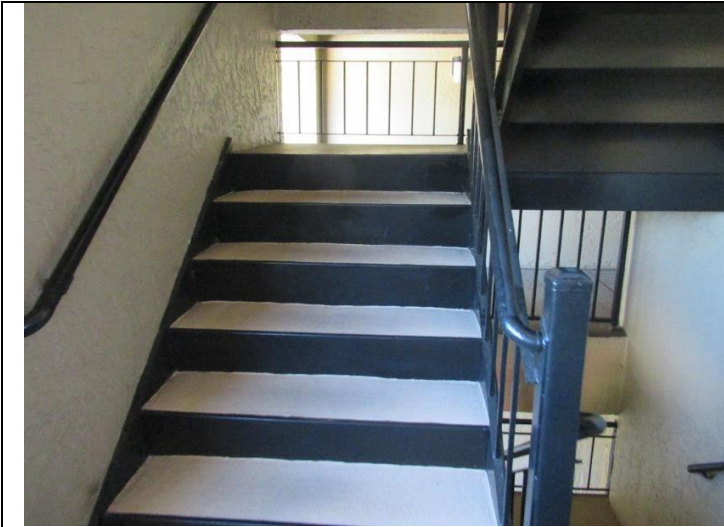
5. Stairwell Overview

Stairwells are located at the corners and center of the building, and appear to be a mix of concrete, with painted steel handrails and/or aluminum treads and risers. No issues observed.

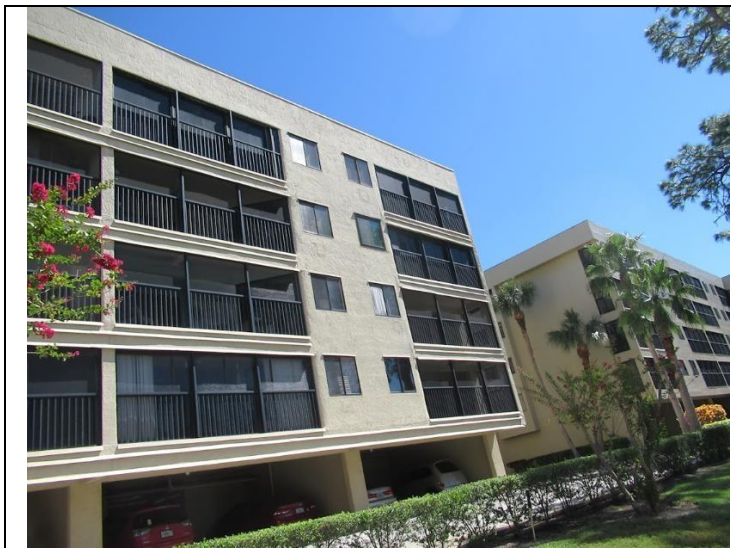
7. Unit Balconies (typical)

The structural systems consisted of concrete masonry unit walls, a solid concrete floor and ceiling, with an aluminum railing system on the outer edges. It is important to note that only 25% of the balconies were inspected from the exterior via a lift system.

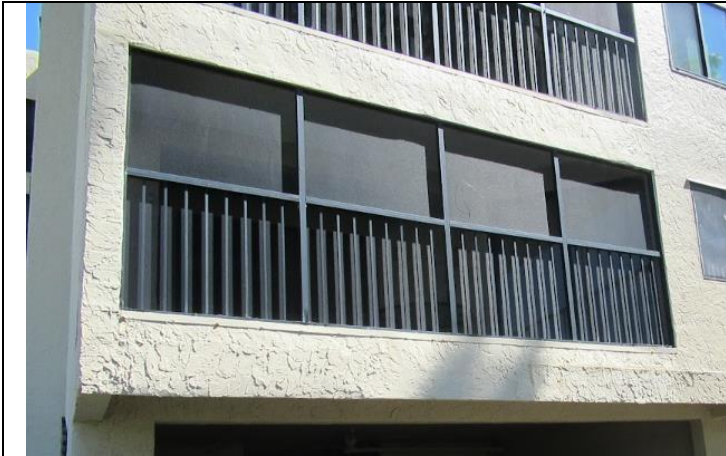
8. Unit Balcony Guard Rail (typical)

Aluminum guardrails are provided along the edges of the balconies with attached posts, top and bottom rails, and intermediate pickets. The railing systems are original and do meet current building codes.

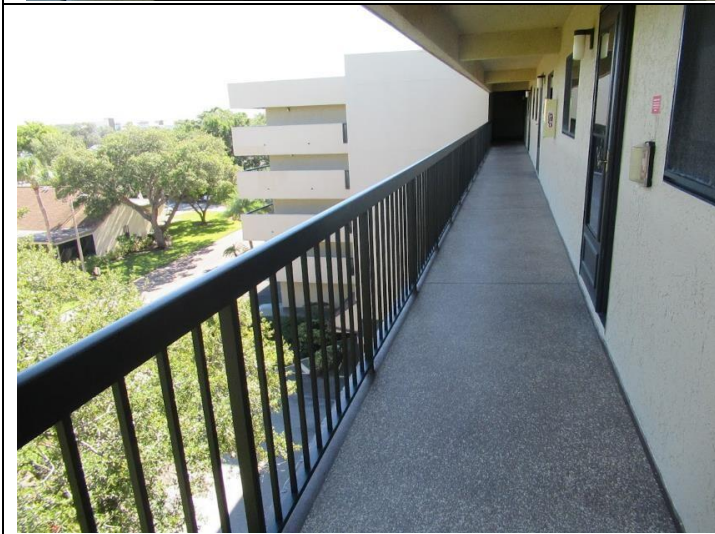
9. Walkways (typical)

Exterior walls and walkways consist of cementitious materials with a painted stucco finish. Floors 1-5, no concern of note.
