# **FULL RESERVE STUDY**

## **9th Fairway Condominium at Green Dolphin Park, Inc.**

**Tarpon Springs, Florida**  
**June 30, 2021**

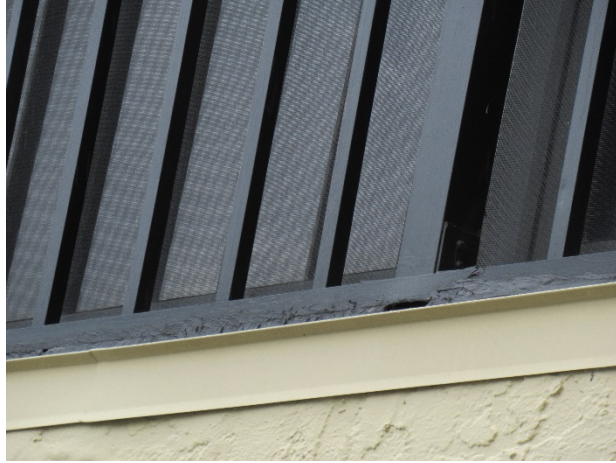
**Condition:** Good to fair overall

**Previous repairs at a balcony railing**

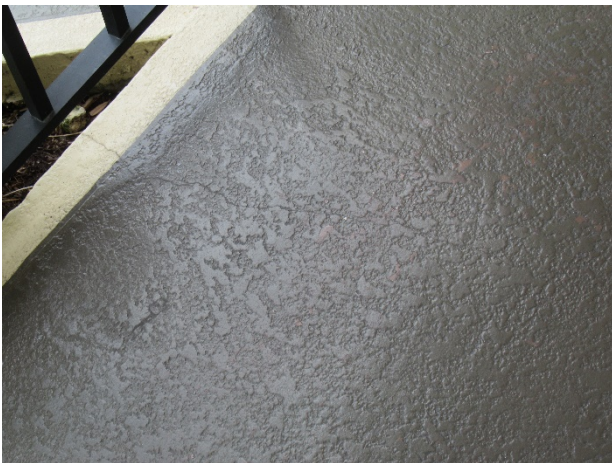
**Condition:** Good to fair overall with isolated cracks and damage evident

**Minor crack at breezeway**

**Useful Life:** Capital repairs including a close-up visual inspection, patching of delaminated concrete, routing and filling of cracked concrete, and waterproof coating applications up to every 20 years with sealer applied up to every five years.

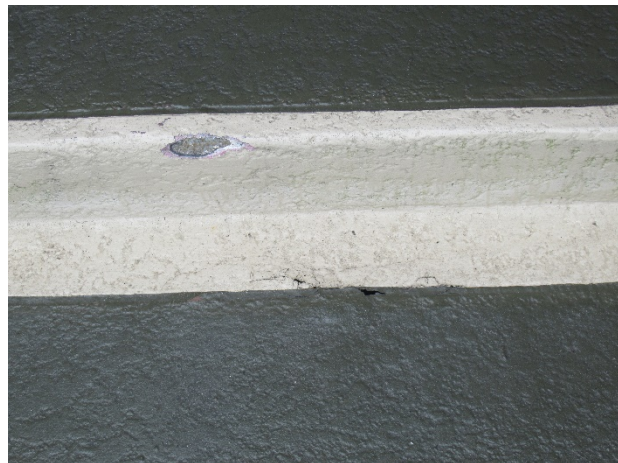
**Coating damage at breezeway**

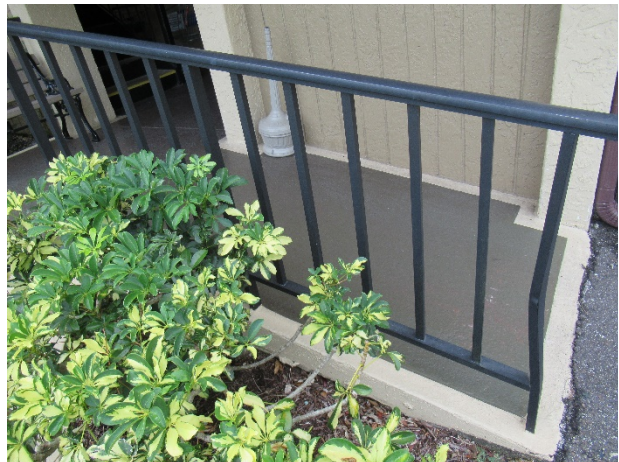
**Condition:** The railings are in good to fair overall condition and the railing finishes are in fair condition. The railings exhibit isolated bent pickets, finish deterioration and previous repairs.

**Breezeway railing with bent picket**

**Useful Life:** Up to 35 years for replacement. At the request of management, we include periodic applications of a protective paint finish and partial replacement of deteriorated aluminum every six- to eight-years.

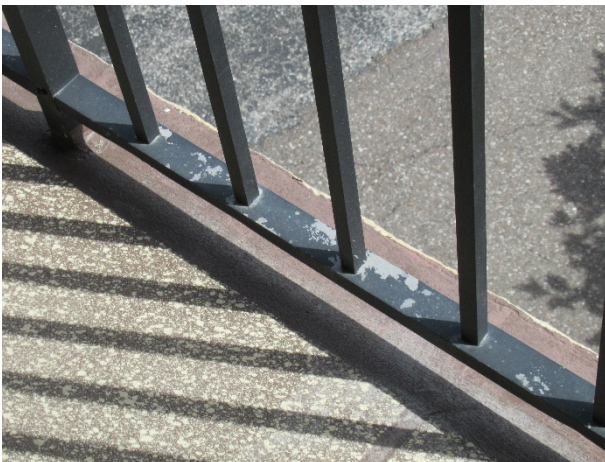
**Breezeway railing finish deterioration**

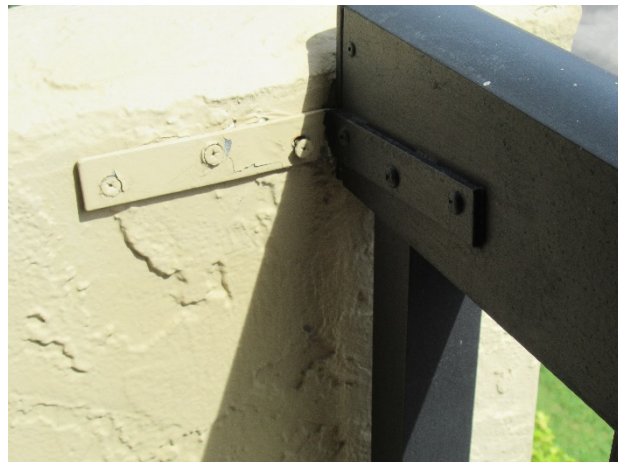
**Previous repair at breezeway railing**

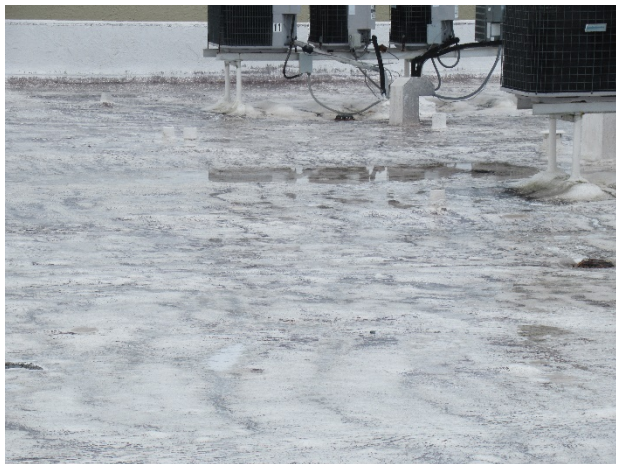
**Condition:** Good to fair overall with standing water evident. Management does not report history of leaks.

Standing water at foam roof

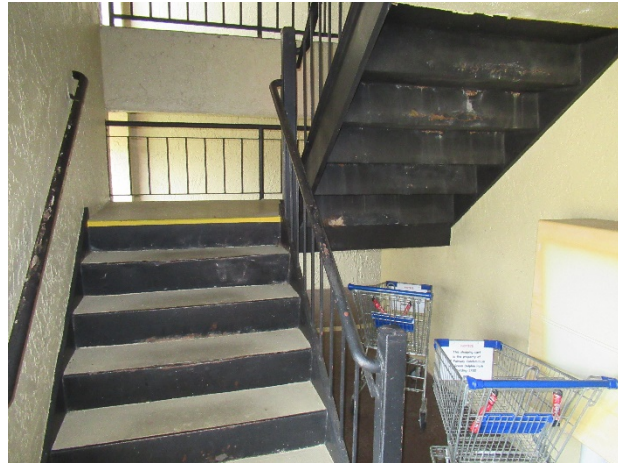
**Condition:** Fair to poor overall with widespread rust evident

Staircase with widespread rust

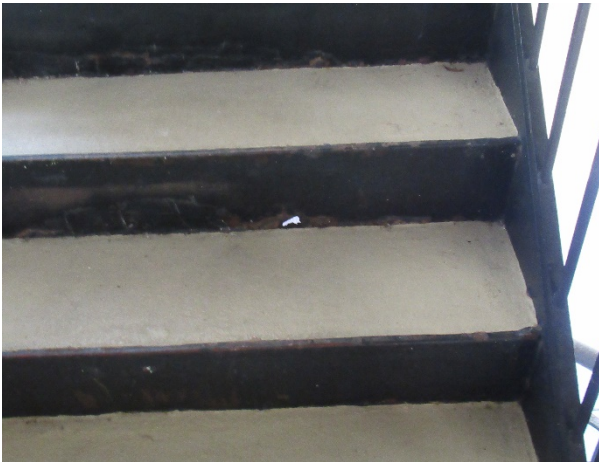
Staircase with rusted through hole

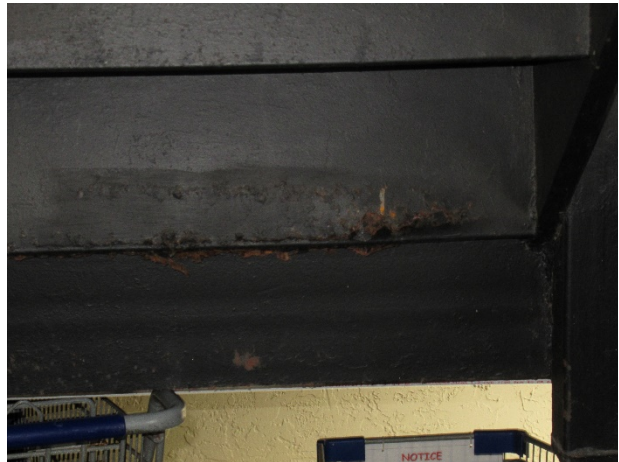
Heavy rust at staircase

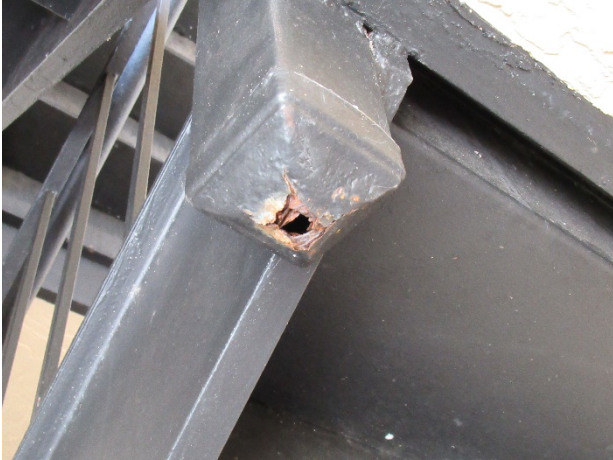
**Rusted staircase component**

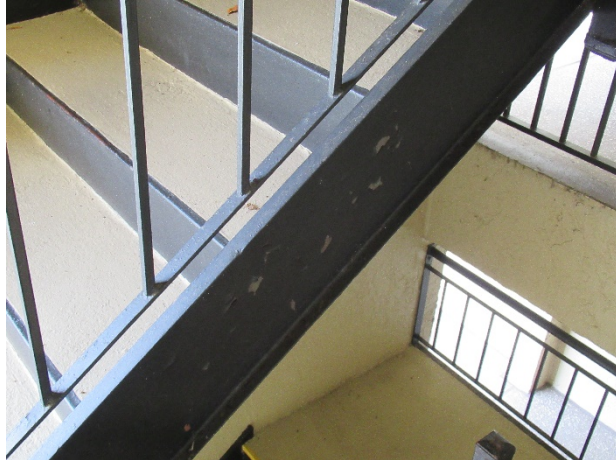
**Peeling paint at staircase**

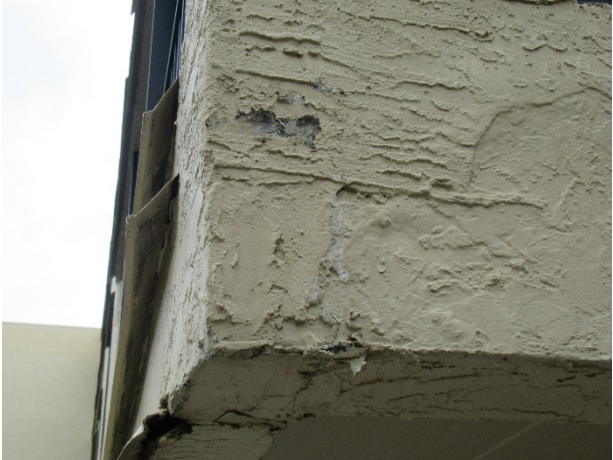
**Condition:** Fair to poor overall with coating deterioration, previous repairs, signs of water intrusion and stains evident

**Isolated wall coating deterioration**

***Useful Life:*** We recommend inspections, repairs and paint finish applications every five-to seven-years.

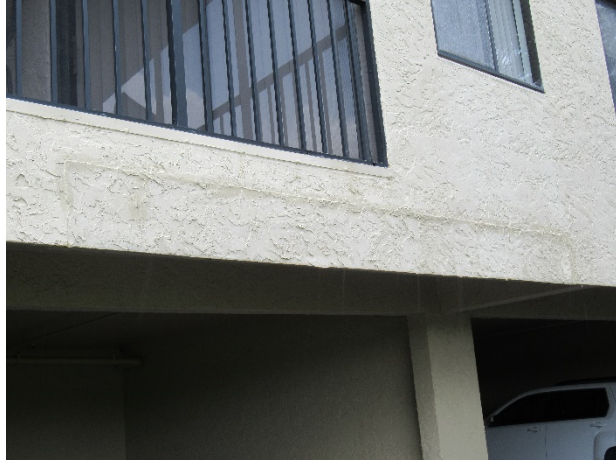
**Previous stucco repair**

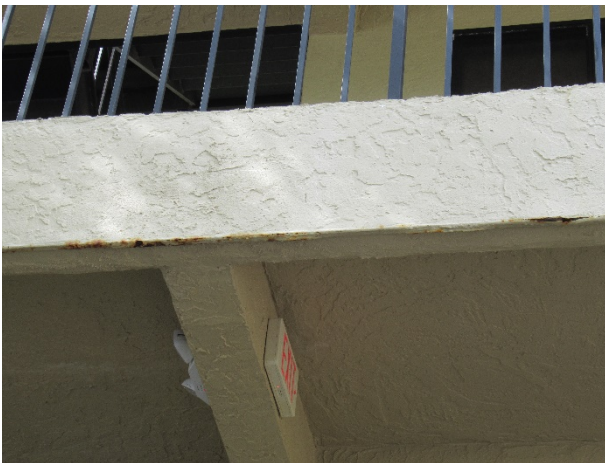
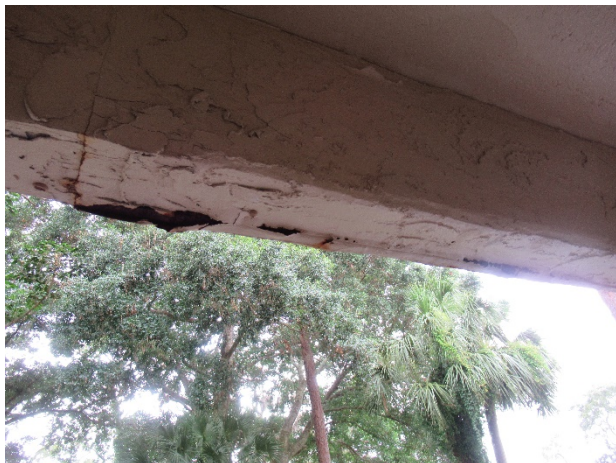
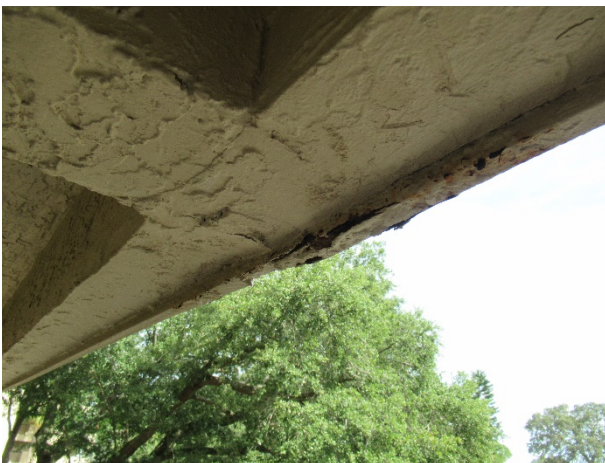
**Signs of water intrusion with rust**

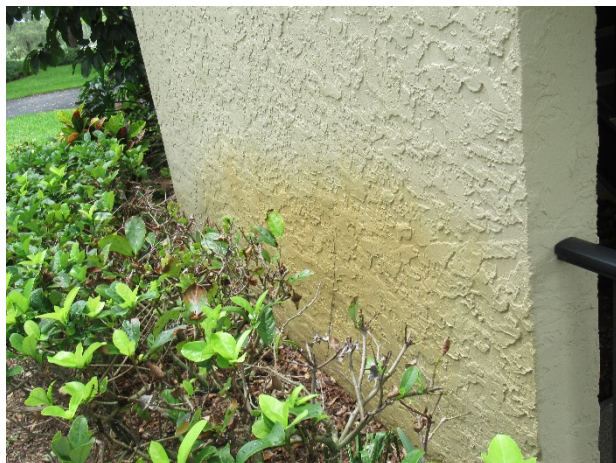
**Isolated stain at stucco wall**

Correct and complete preparation of the surface before application of the paint finish maximizes the useful life of the paint finish and surface. The contractor should remove all loose, peeled or blistered paint before application of the new paint finish. The contractor should then power wash the surface to remove all dirt and biological growth. Water-soluble cleaners that will not attack Portland cement are acceptable for removing stains.

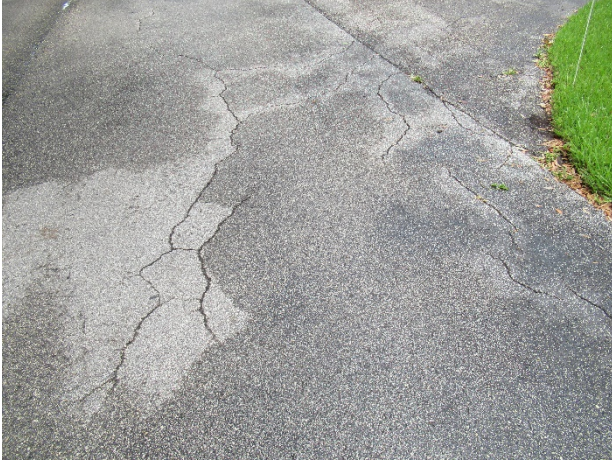
**Condition:** Fair overall with cracks, patches, raveling and settlement evident

**Asphalt pavement cracks**

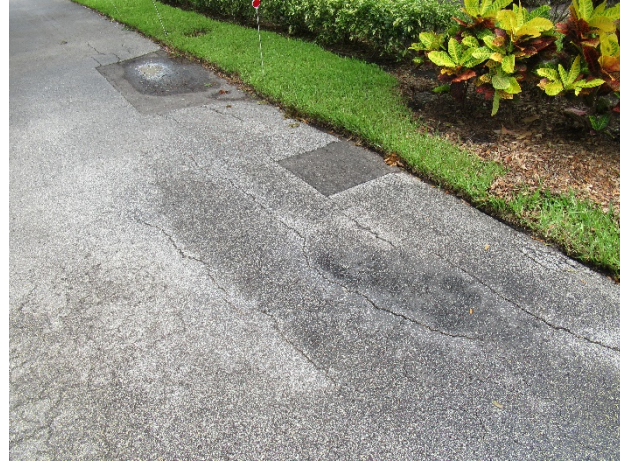
**Longitudinal cracks, patches and settlement**

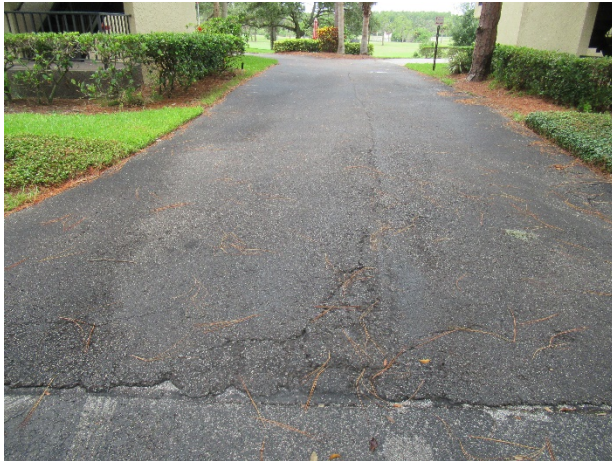
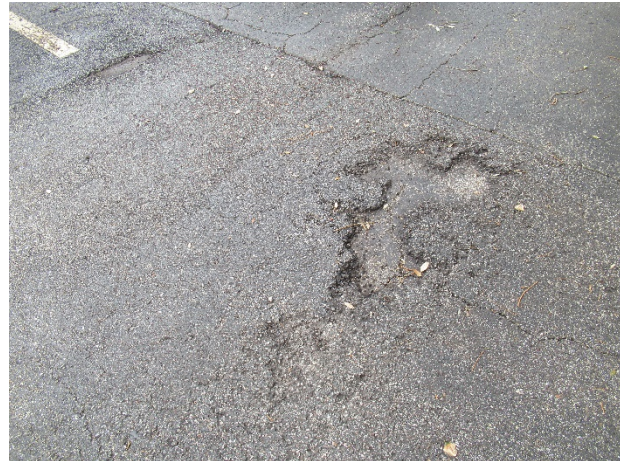
**Cracks and raveling at pavement**

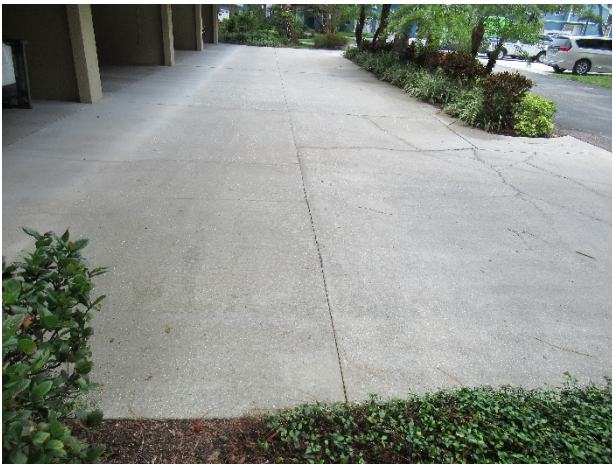
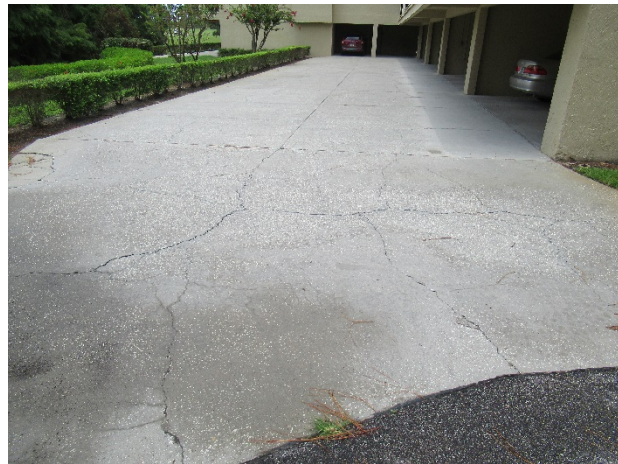
**Condition:** Good to fair overall with cracks evident

Concrete driveway with cracks

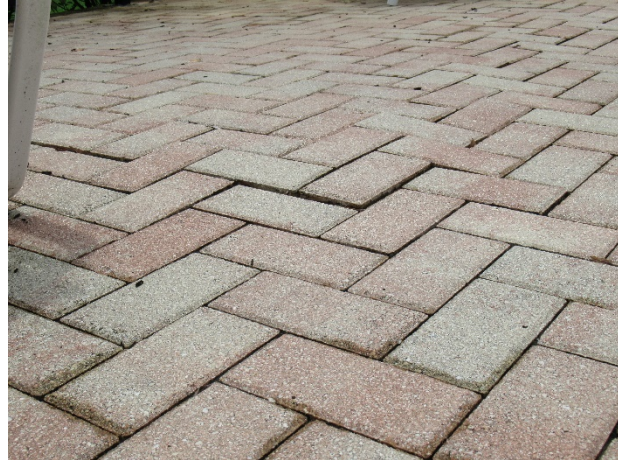
**Condition:** Good to fair condition with isolated settlement evident

Minor settlement at pool deck pavers

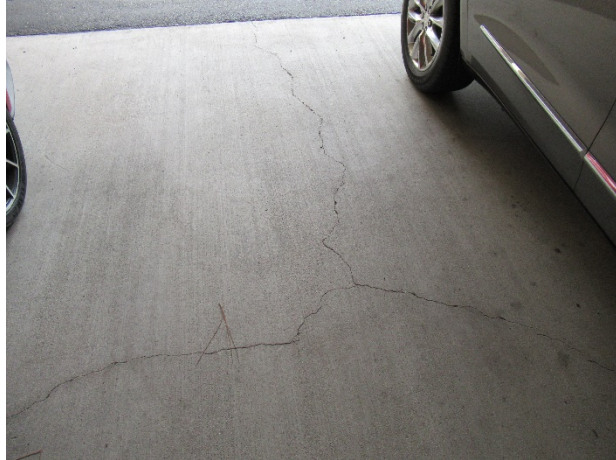
**Condition:** Good to fair overall with isolated cracks evident

**Concrete crack at garage**
