PHASE 1 MILESTONE INSPECTION REPORT

9th Fairway Condominium at Green Dolphin Park, Inc.

1700,1800,1900 Golfview Drive Tarpon
Springs, FL 34689

November 29th, 2023

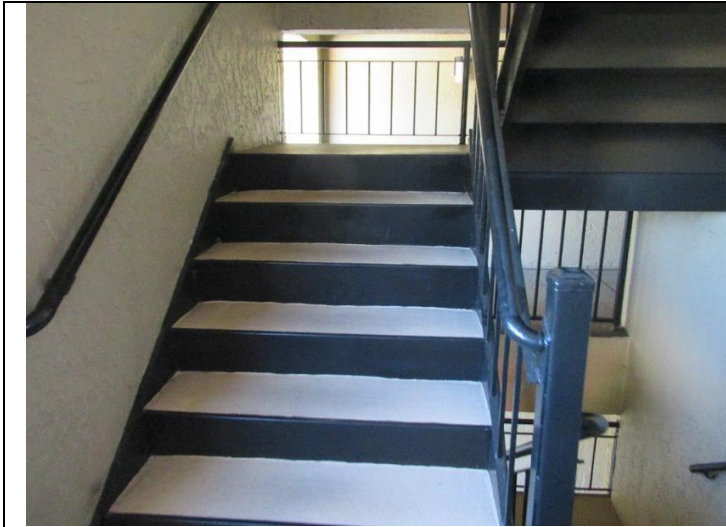
5. Stairwell Overview

Stairwells are located at the corners and center of the building, and appear to be a mix of concrete, with painted steel handrails and/or aluminum treads and risers. No issues observed.
