COMMERCIAL WINDSTORM MITIGATION REPORT (OIR-B1-1802)

9th Fairway Condominium at Green Dolphin Park, Inc.

1700 Golfview Dr

As of 12/9/2019

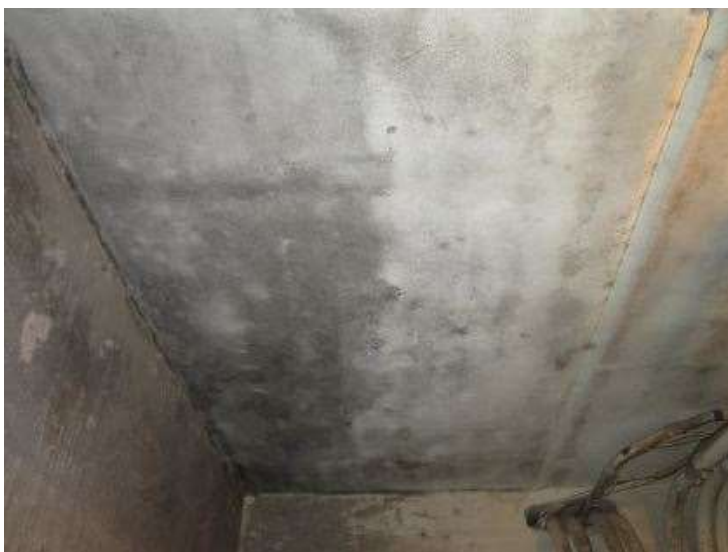
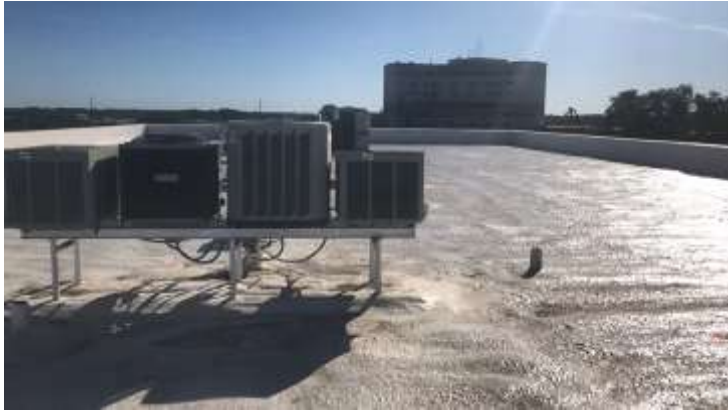
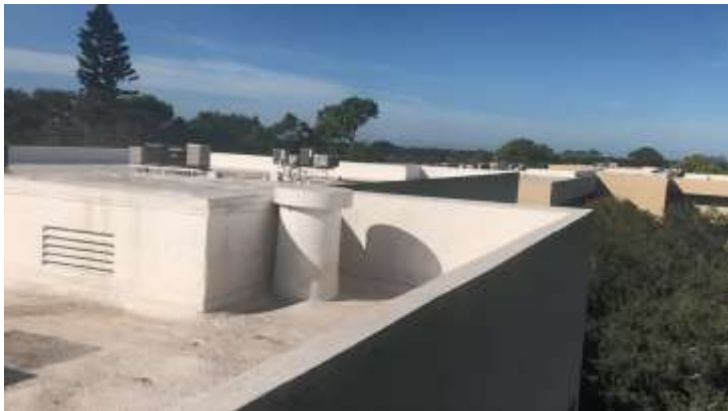
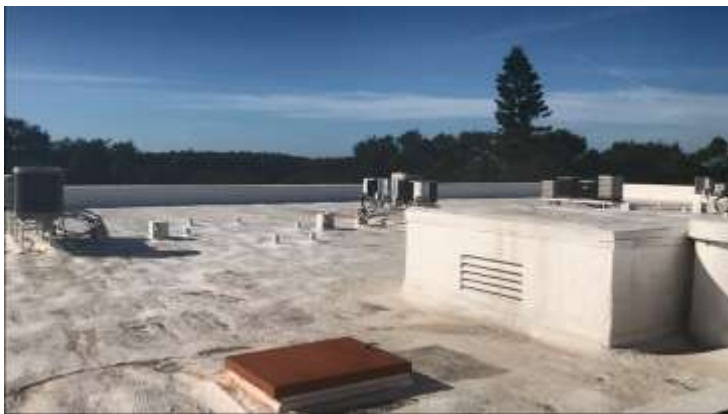
Roof Construction

3. **Roof Deck Attachment:** **Reinforced Concrete Roof Deck**
Comments: Inspection verified a roof structure composed of pre-cast structural concrete designed to be self supporting and integrally attached to the wall / support system.

4. **Roof to Wall Attachment:** **Structural**
Comments: Inspection verified a roof structure composed of pre-cast structural concrete designed to be self supporting and integrally attached to the wall / support system.

5. **Roof Geometry:** **Flat Roof**
Comments: Inspection verified a flat roof shape.
6. **SWR:** **No**
Comments: SWR does not apply to reinforced concrete roof decks.
