COMMERCIAL WINDSTORM MITIGATION REPORT (OIR-B1-1802)

9th Fairway Condominium at Green Dolphin Park, Inc.

1800 Golfview Dr

As of 12/9/2019

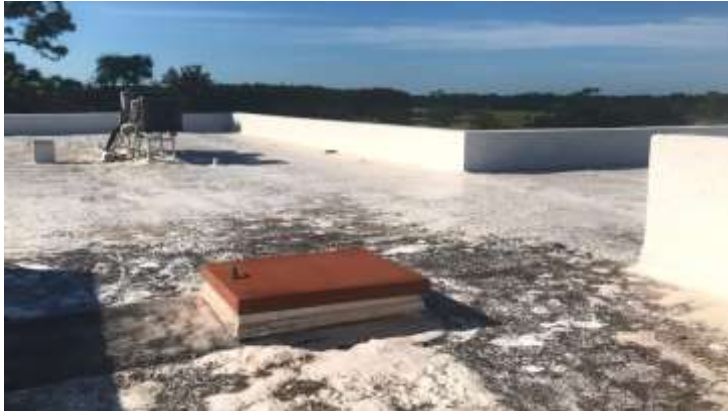
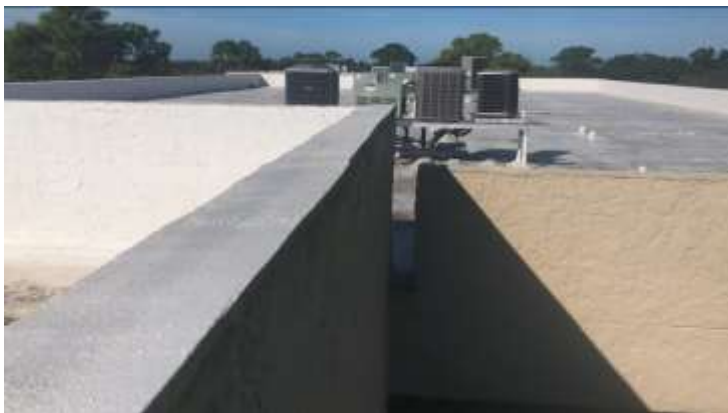
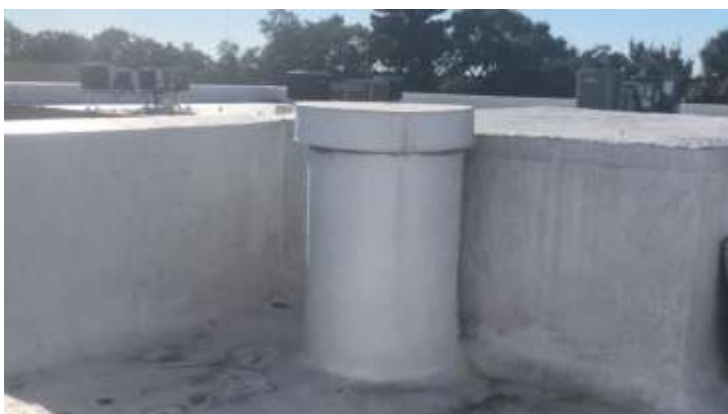
Roof Construction

3. **Roof Deck Attachment:** **Reinforced Concrete Roof Deck**
Comments: Inspection verified a roof structure composed of pre-cast structural concrete designed to be self supporting and integrally attached to the wall / support system.

4. **Roof to Wall Attachment:** **Structural**
Comments: Inspection verified a roof structure composed of pre-cast structural concrete designed to be self supporting and integrally attached to the wall / support system.

5. **Roof Geometry:** **Flat Roof**
Comments: Inspection verified a flat roof shape.
6. **SWR:** **No**
Comments: SWR does not apply to reinforced concrete roof decks.
