## COMMERCIAL WINDSTORM MITIGATION REPORT (OIR-B1-1802)

9th Fairway Condominium at Green Dolphin Park, Inc.

1900 Golfview Dr

As of 12/9/2019

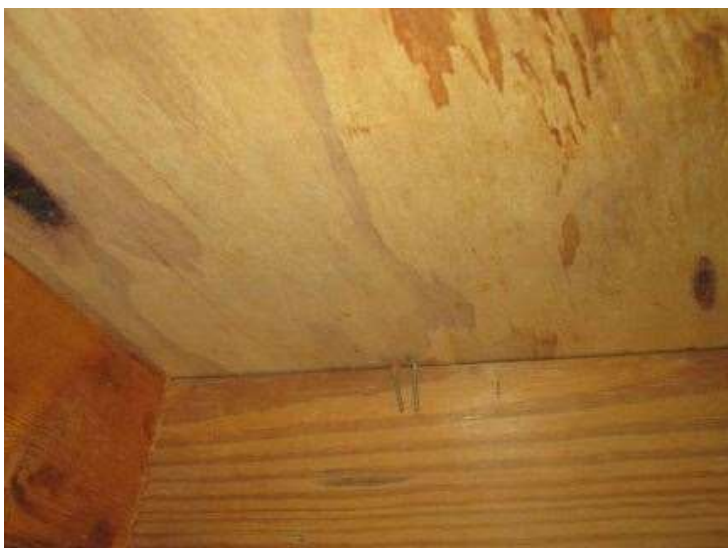
Roof Construction

3. **Roof Deck Attachment:**        **Level A**  
Comments:                                      Inspection verified 1/2" plywood roof deck attached with staples at a minimum of 6" on the edge & 12" in the field.
