COMMERCIAL WINDSTORM MITIGATION REPORT

9th Fairway Condominium at Green Dolphin Park, Inc.

COMMERCIAL WINDSTORM MITIGATION REPORT (OIR-B1-1802)

1700 Golfview Dr

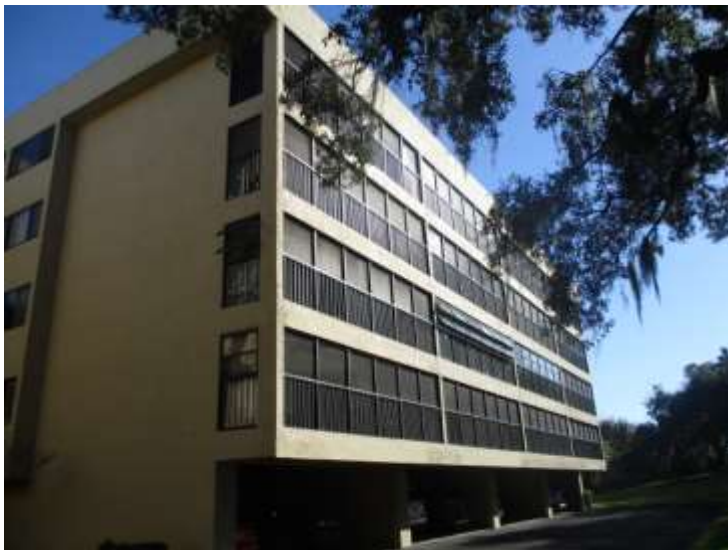
Exterior Elevation

| 7. <u>Opening Protection:</u> Comments: | None or Some Glazed Openings No opening protection verified at time of inspection. |

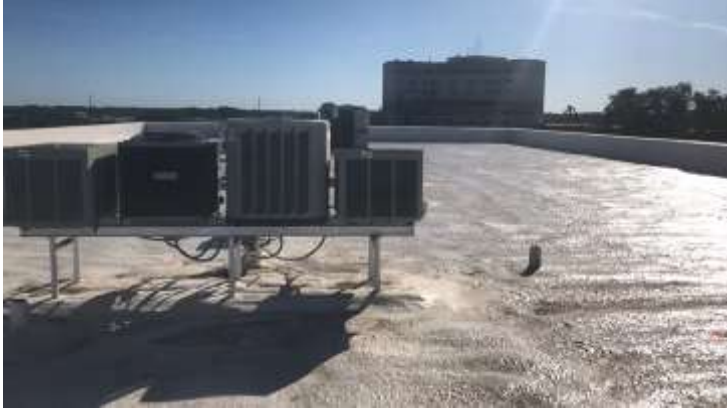
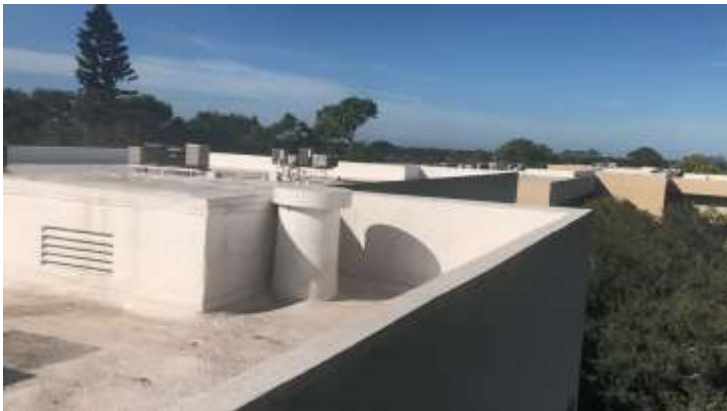
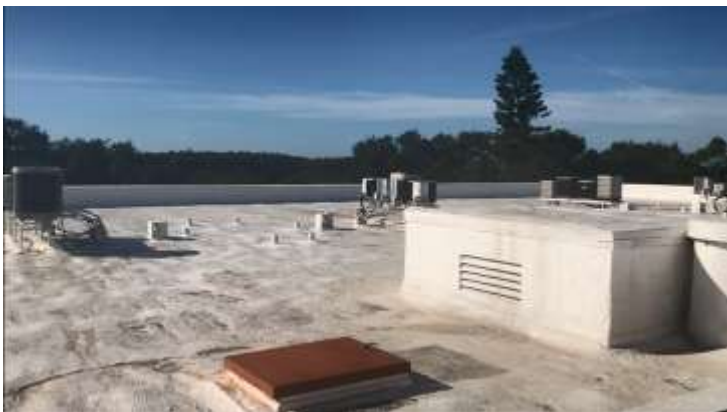
Roof Construction

| 3. <u>Roof Deck Attachment:</u> Comments: | Reinforced Concrete Roof Deck Inspection verified a roof structure composed of pre-cast structural concrete designed to be self supporting and integrally attached to the wall / support system. |
| 4. <u>Roof to Wall Attachment:</u> Comments: | Structural Inspection verified a roof structure composed of pre-cast structural concrete designed to be self supporting and integrally attached to the wall / support system. |
| 5. <u>Roof Geometry:</u> Comments: | Flat Roof Inspection verified a flat roof shape. |

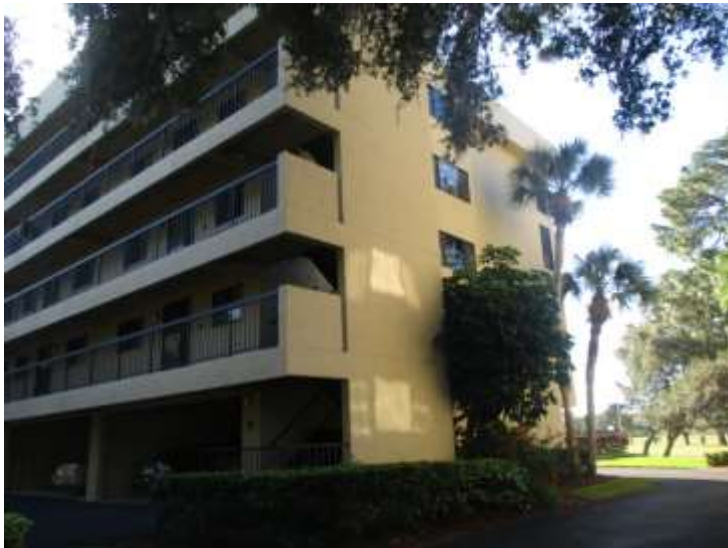
Exterior Elevation

| 7. <u>Opening Protection:</u> Comments: | None or Some Glazed Openings No opening protection verified at time of inspection. |

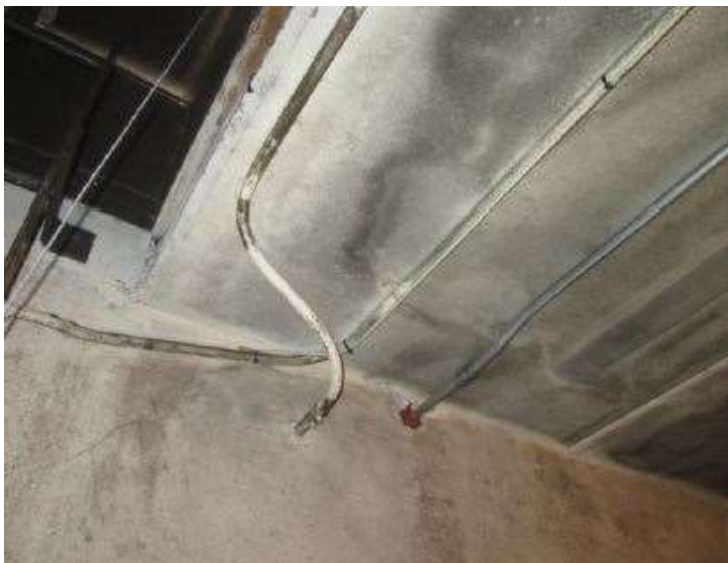
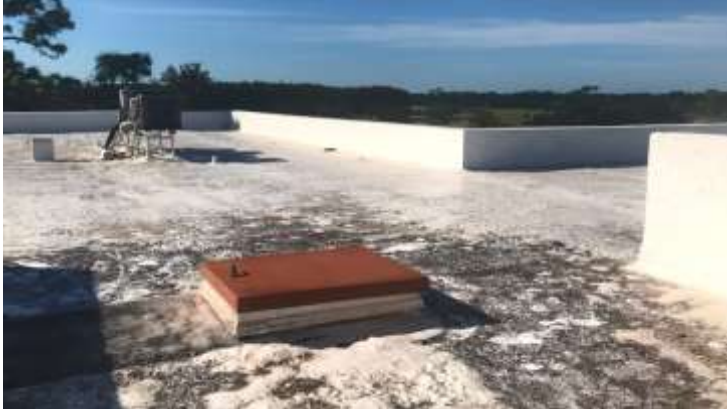
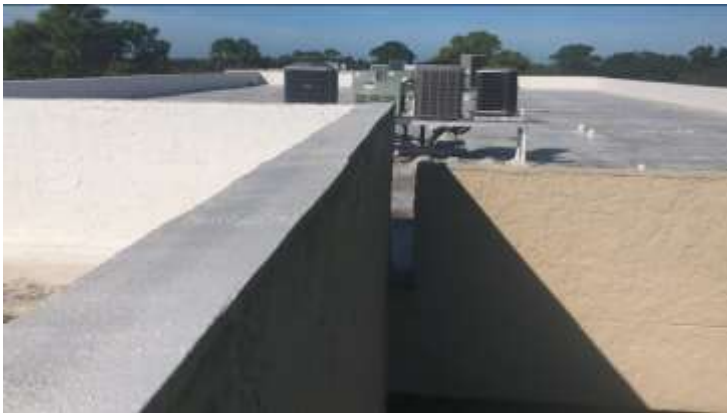
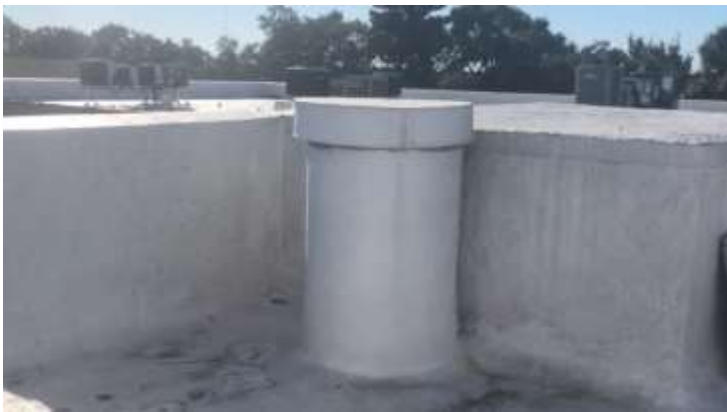
Roof Construction

| 2. <u>Roof Covering:</u> Comments: | No roof coverings meet the minimum requirements The roof covering is not original; however, no permit information was found with the local Building Department. This roof was re-coated in 2016. This roof was verified as not meeting the requirements outlined on the mitigation affidavit. |

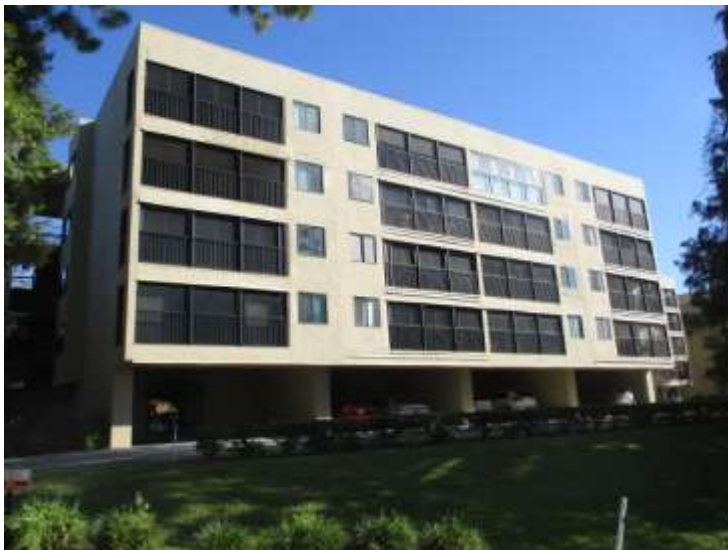
Exterior Elevation

| 7. <u>Opening Protection:</u> Comments: | None or Some Glazed Openings No opening protection verified at time of inspection. |

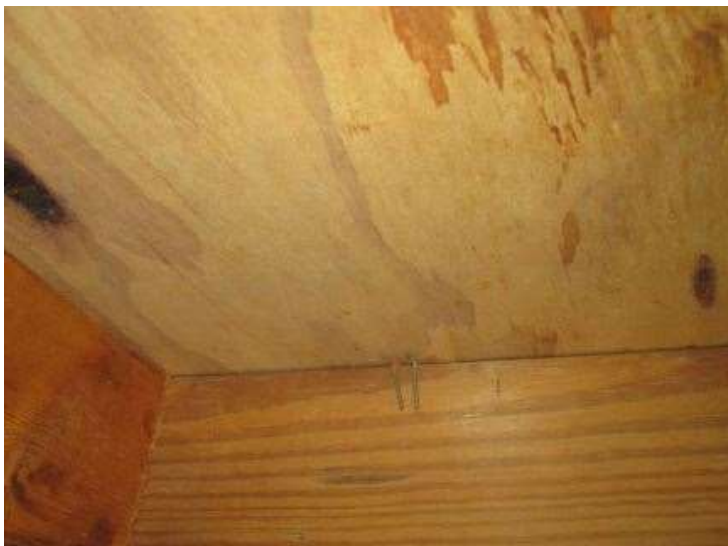
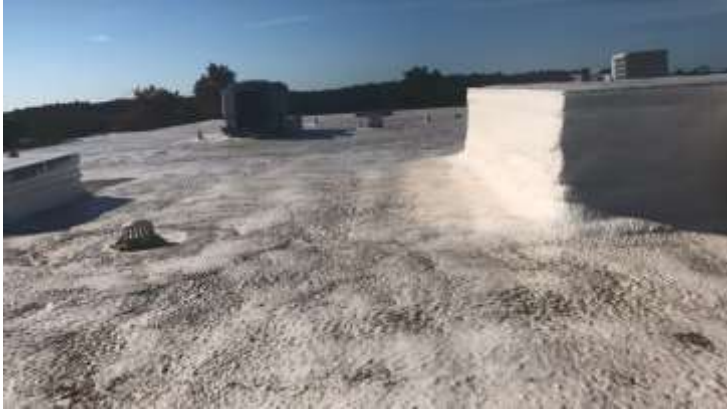
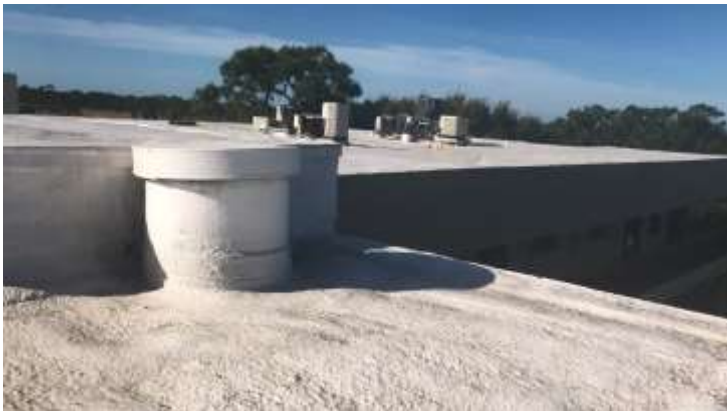
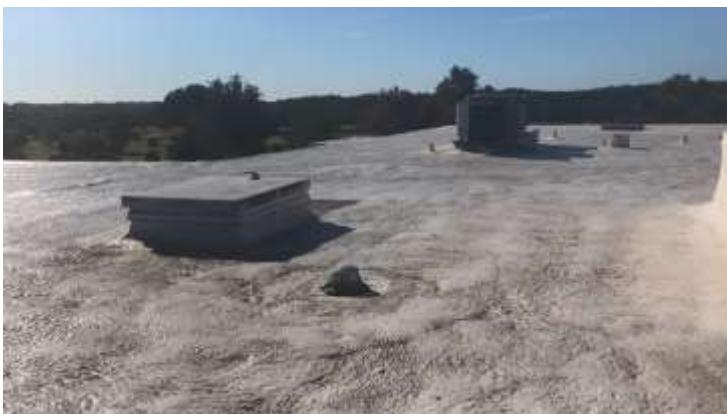
Roof Construction

| 2. <u>Roof Covering:</u> Comments: | No roof coverings meet the minimum requirements The roof covering is not original; however, no permit information was found with the local Building Department. This roof was re-coated in 2016. This roof was verified as not meeting the requirements outlined on the mitigation affidavit. |

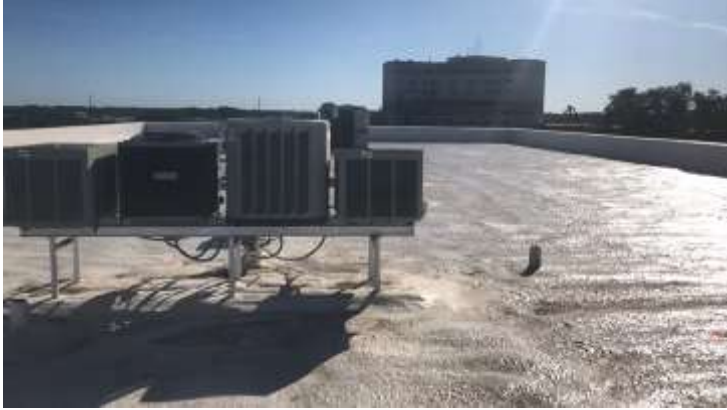
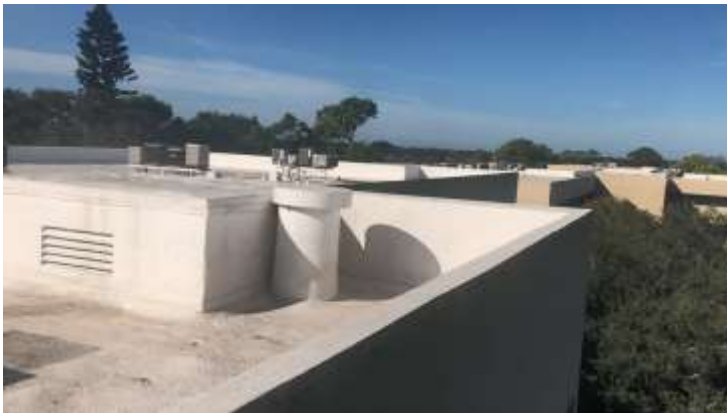
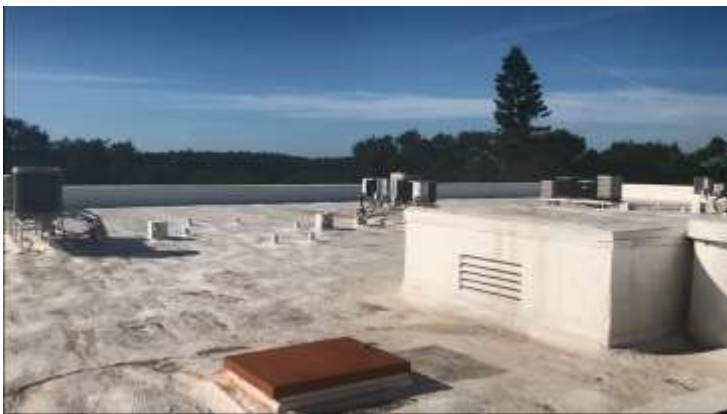
Roof Construction

| 1. <u>Roof Covering:</u> Comments: | FBC Equivalent The roof covering was replaced in 2004. The roof permit was confirmed and the permit number is 0100000620. This roof was re-coated in 2016. This roof was verified as meeting the building code requirements outlined on the mitigation affidavit. |

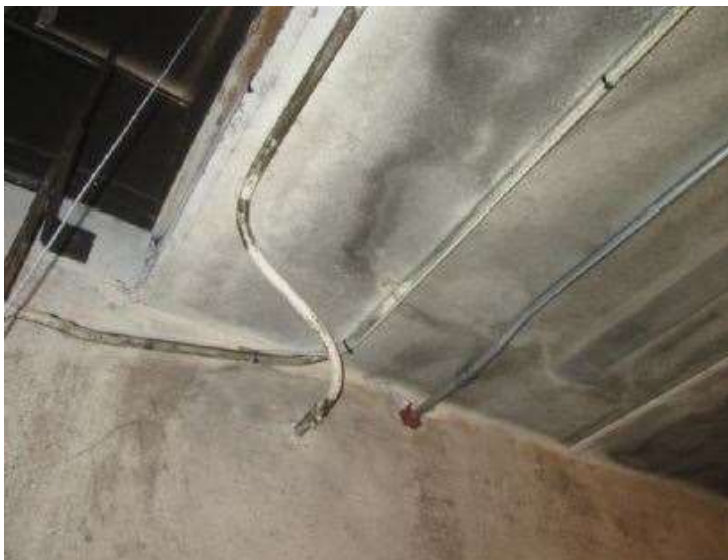
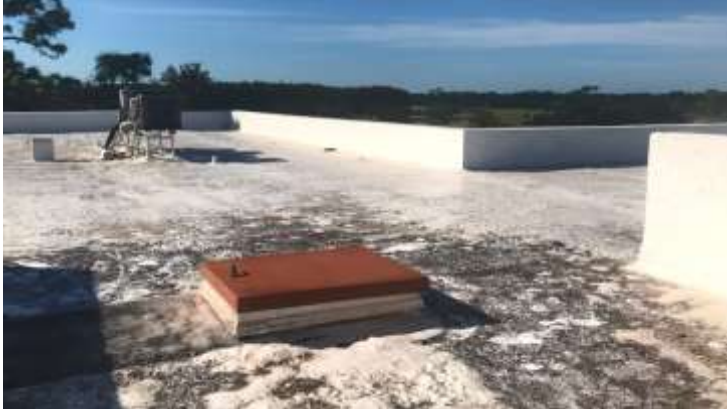
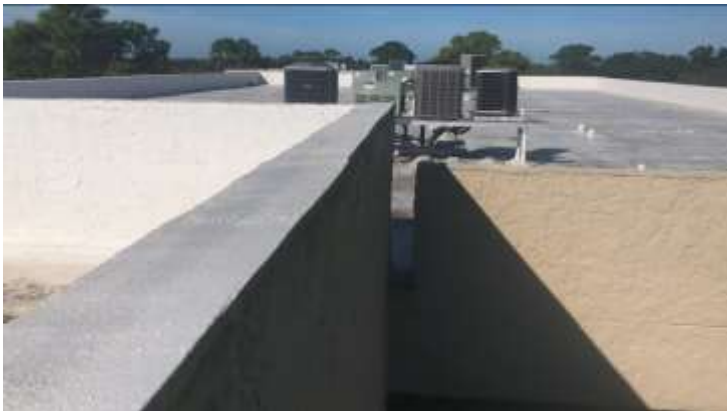
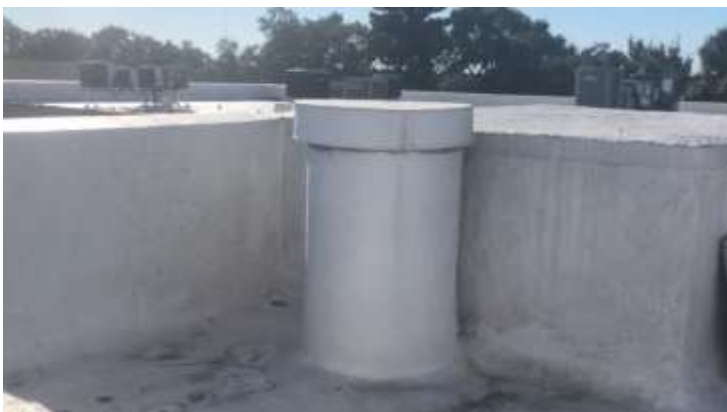
Roof Construction

| 1. <u>Roof Covering:</u> Comments: | No roof coverings meet the minimum requirements The roof covering is not original; however, no permit information was found with the local Building Department. This roof was re-coated in 2016. This roof was verified as not meeting the requirements outlined on the mitigation affidavit. |

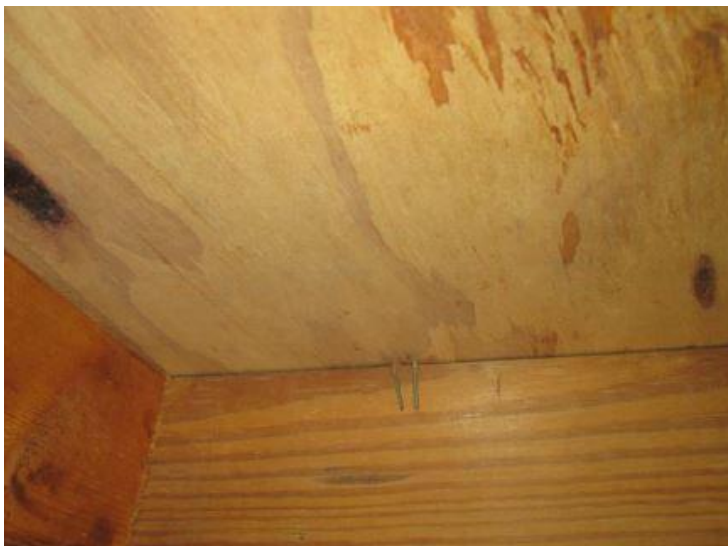
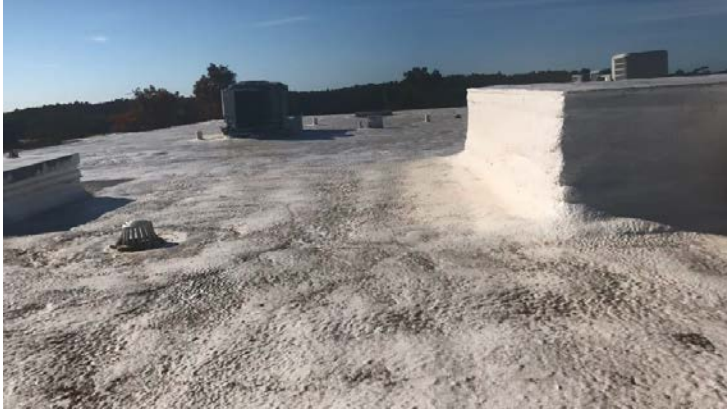
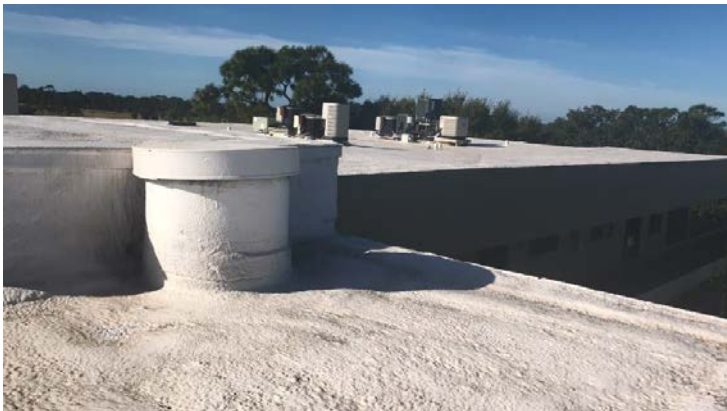
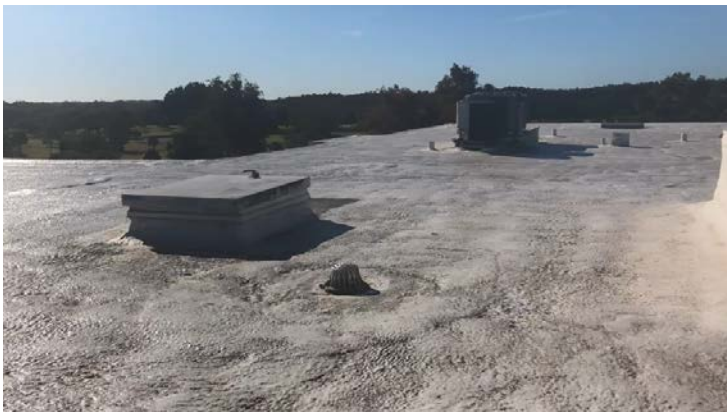
Roof Construction

| 1. <u>Roof Covering:</u> Comments: | No roof coverings meet the minimum requirements The roof covering is not original; however, no permit information was found with the local Building Department. This roof was re-coated in 2016. This roof was verified as not meeting the requirements outlined on the mitigation affidavit. |
