# **FULL RESERVE STUDY**

## **9th Fairway Condominium at Green Dolphin Park, Inc.**

**Tarpon Springs, Florida**  
**June 30, 2021**

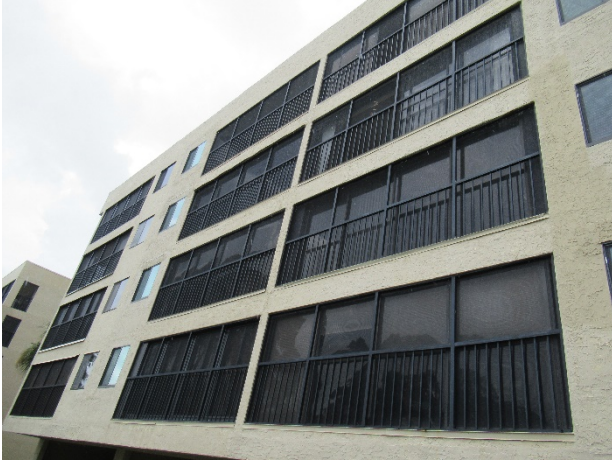
**Condition:** Good to fair overall

**Typical balcony railings with screen enclosures**

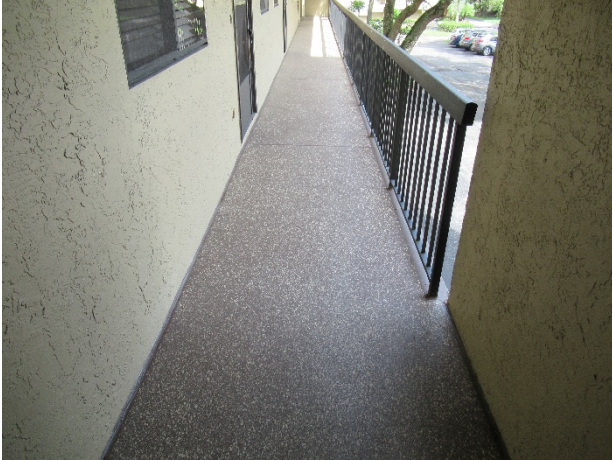
**Condition:** Good to fair overall with isolated cracks and damage evident

**Typical breezeway and waterproof coating**

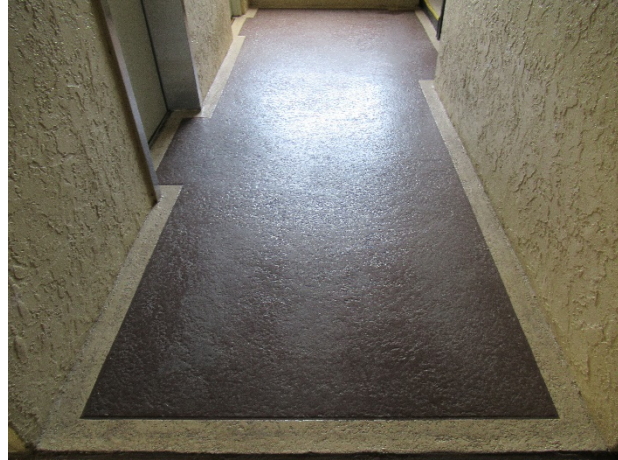
**Waterproof coating at breezeway**

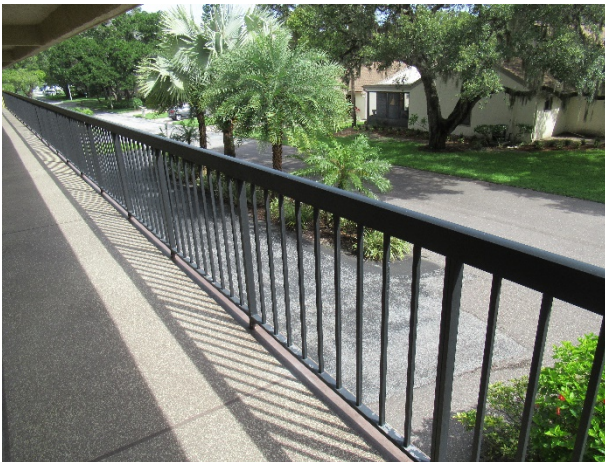
**Condition:** The railings are in good to fair overall condition and the railing finishes are in fair condition. The railings exhibit isolated bent pickets, finish deterioration and previous repairs.

**Typical breezeway railing**

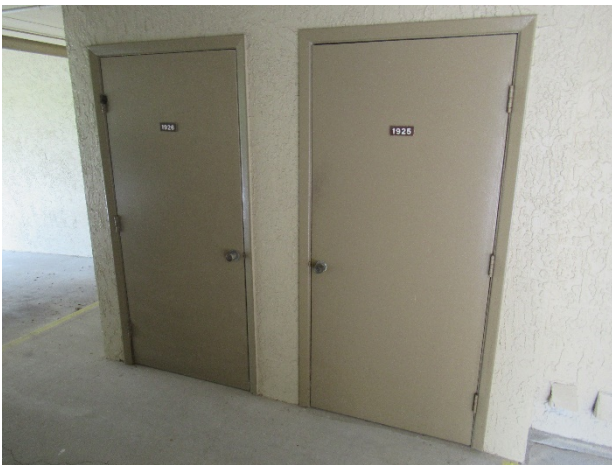
**Condition:** Good to fair overall with no significant deterioration evident

Typical common doors at garages

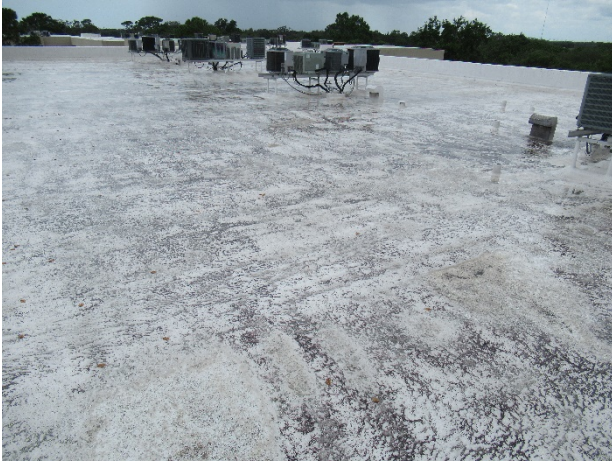
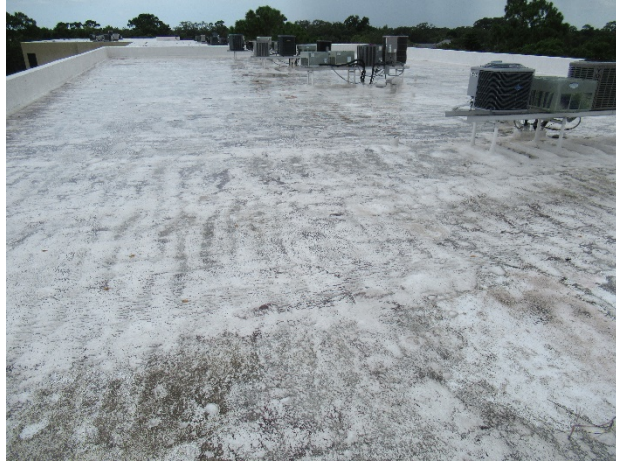
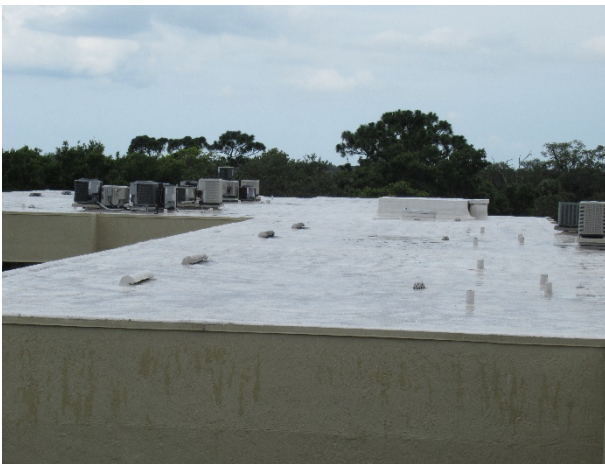
**Condition:** Good to fair overall with standing water evident. Management does not report history of leaks.

Overview of foam roof

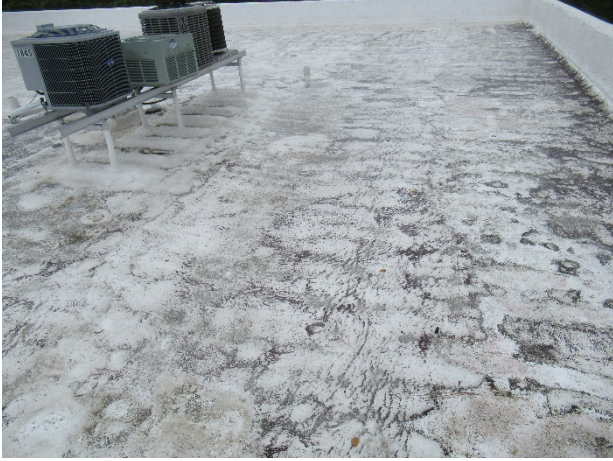
**Typical foam roof**

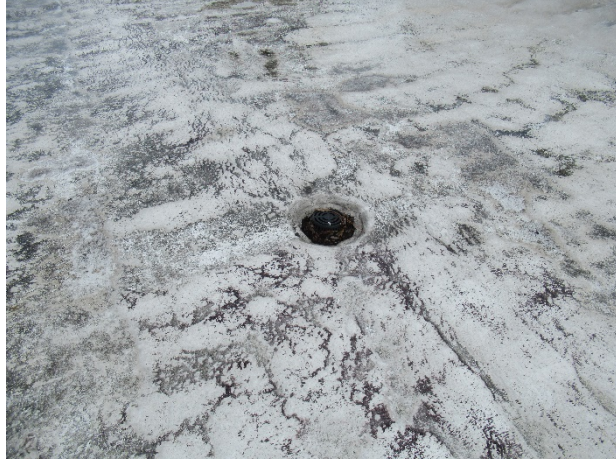
**Typical drain at foam roof**

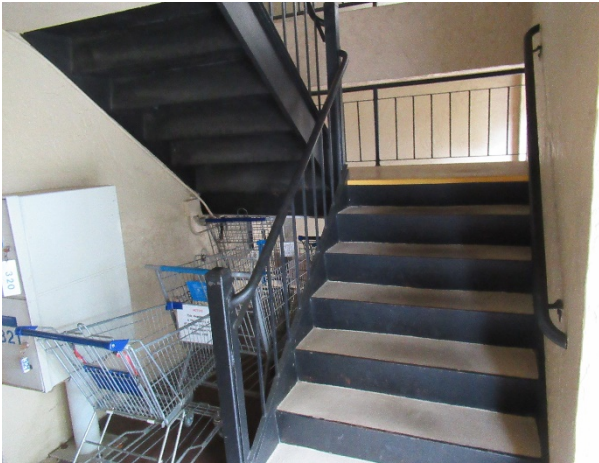
**Condition:** Fair to poor overall with widespread rust evident

Typical remaining staircase

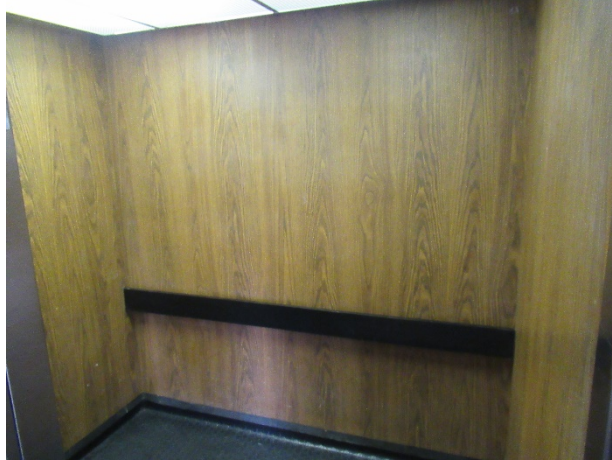
**Condition:** Good to fair overall

**Typical cab finishes**

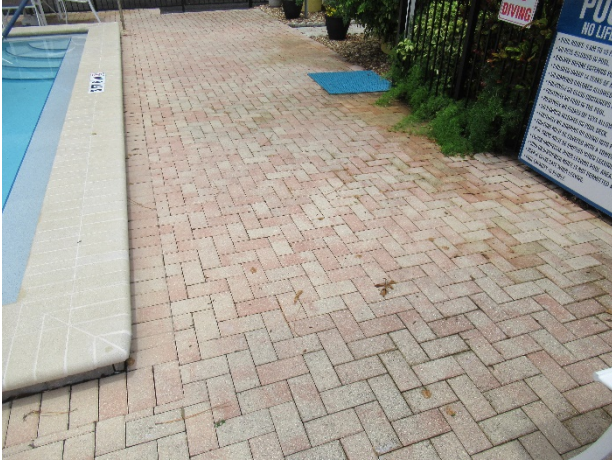
**Condition:** Good to fair condition with isolated settlement evident

Typical pavers at pool deck

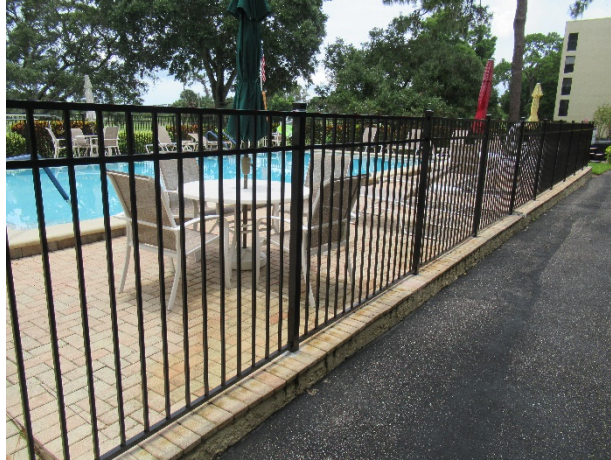
**Condition:** Good overall

**Aluminum fence at pool**

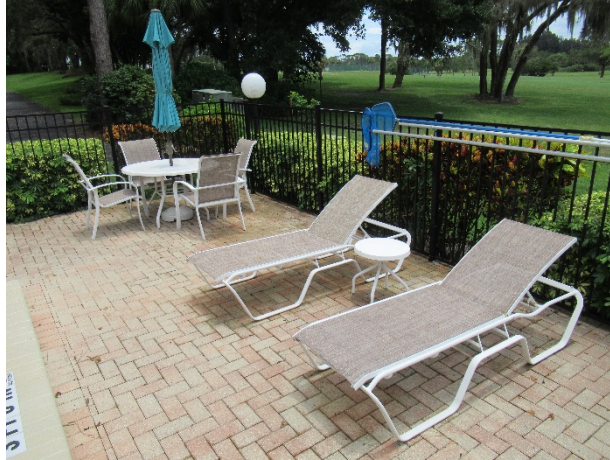
**Condition:** Good to fair overall

**Typical pool furniture**

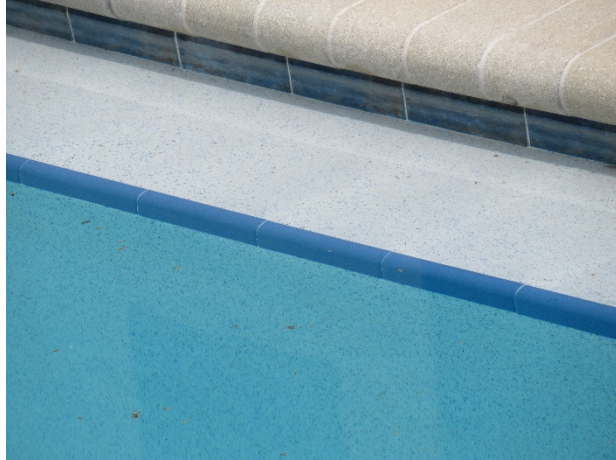
**Condition:** We note no visible deterioration.

Typical pool plaster and tile

- Removal and replacement of the plaster and tile finish
- Partial replacements of the scuppers and coping as needed
- Replacement of joint sealants as needed
- Concrete structure repairs as needed

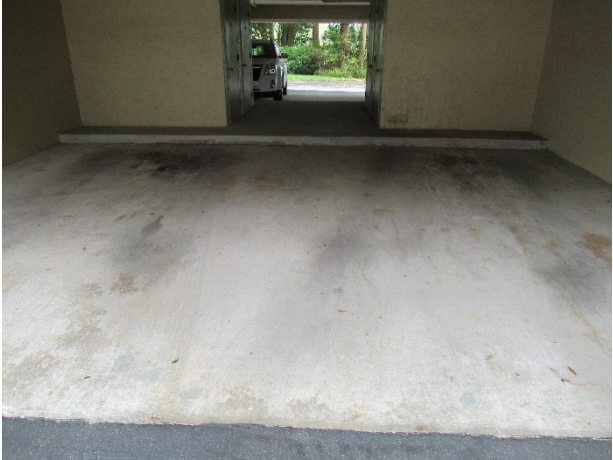
**Condition:** Good to fair overall with isolated cracks evident

**Typical on-grade concrete at garage**

- Complete inspection of the floor
- Selective cut out and replacement of up to six percent (6%), or 1,555 square feet, of the on-grade concrete

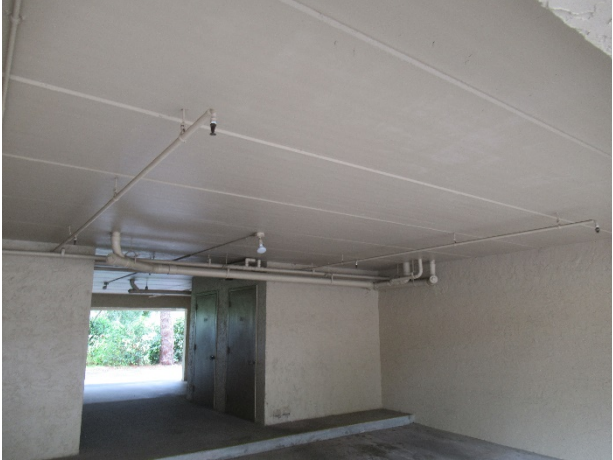
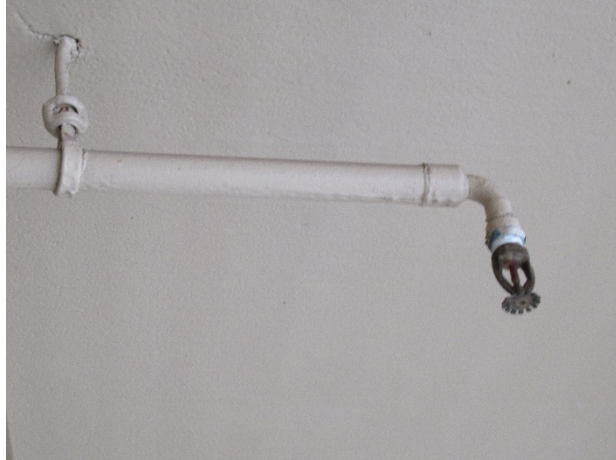
**Condition:** Reported satisfactory

Typical fire suppression system at garage

Typical fire suppression sprinkler head
